## RESIDENTIAL INSPECTION

# TABLE OF CONTENTS

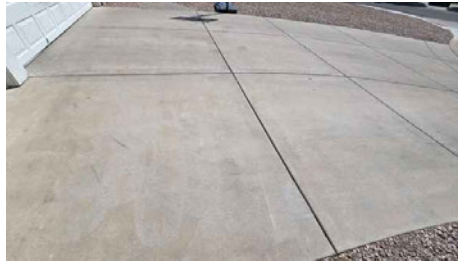
#### Driveway & Walkways: Driveway Condition

No deficiencies were present at the time of inspection.

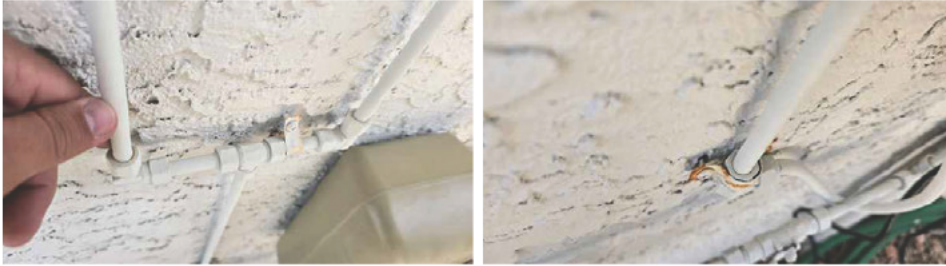
#### LOOSE BRACKETS

The misting system supply lines have loose brackets that need to be better secured.

Contact a qualified handyman.

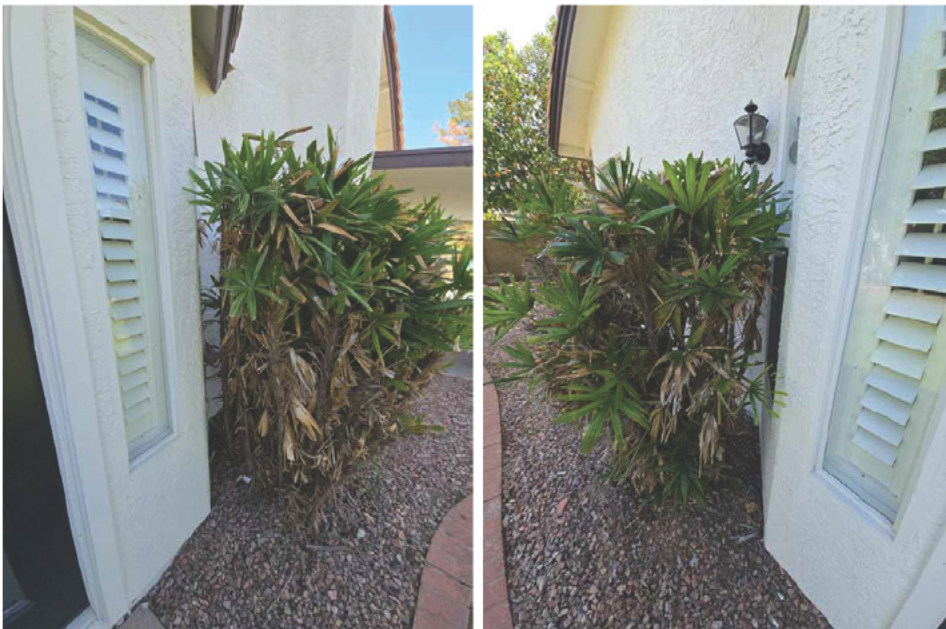
#### 2.2.1 Landscaping Observations

Vegetation is encroaching on the structure, and should be kept a minimum of twelve inches away for the general welfare of the walls and foundation. Bushes, shrubs, flowers and even grass right against the house can cause a multitude of issues. Moisture from watering the plants can accumulate near the foundation, which over time can lead to deterioration of the foundation. People often unintentionally direct irrigation to spray on the plants near the house, which leads to water spraying directly on the house. Over time, this water can deteriorate the stucco or siding. The water can also attract insects, such as termites. Because the damage from water spraying on the house is not readily visible, it can often take years before the problem is noticed, in which time the damage can potentially be extensive.

Contact a qualified landscaping contractor

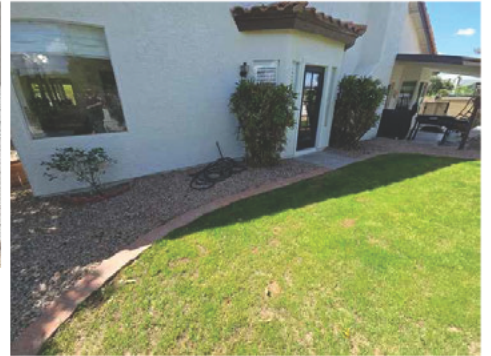
#### 2.4.1 Grading & Drainage

Grading and drainage is either negative or neutral adjacent to the residence, and moisture intrusion will remain a possibility. The soil or the hard surfaces should slope away from the residence to a distance of at least six feet, to keep moisture away from the footing. **Action recommended** from a grading and drainage contractor.

Contact a qualified grading contractor.

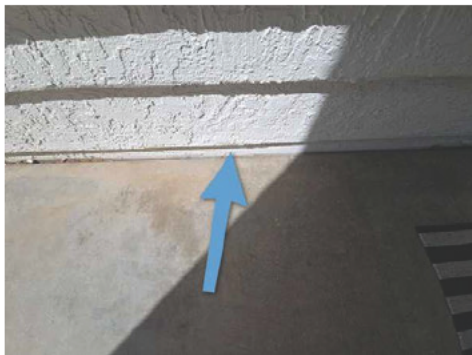
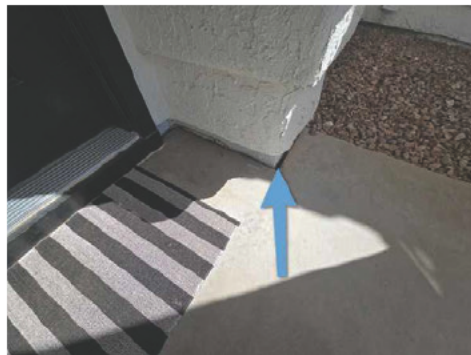
### 2.5.1 Driveway & Walkways

#### **EXPANSION BOARD LIFTED OR ABSENT**

Contact a handyman or DIY project

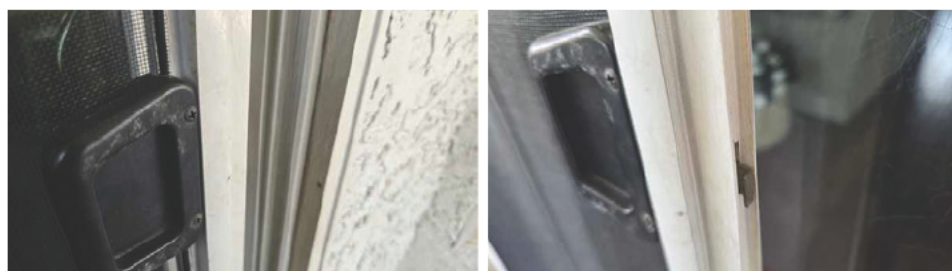
### SLIDING SCREEN DOOR MISSING LATCH

The sliding screen door is missing a hook for the latch that you may wish to have replaced.

Recommendation  
Contact a qualified handyman.

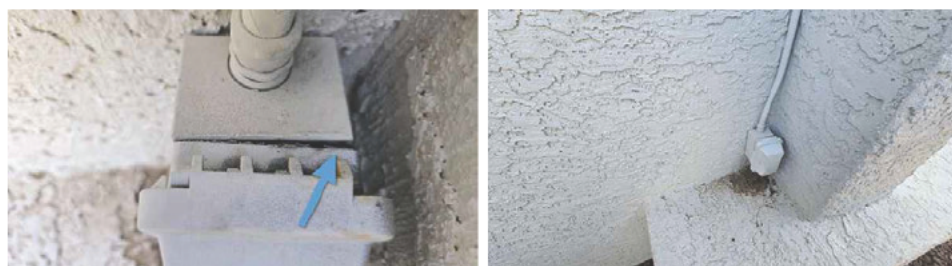
### WEATHER COVER - DAMAGED

A weather cover is damaged for an outlet. The weather covers should be replaced or appropriately sealed to prevent moisture intrusion into the outlet.

Recommendation  
Contact a qualified handyman.

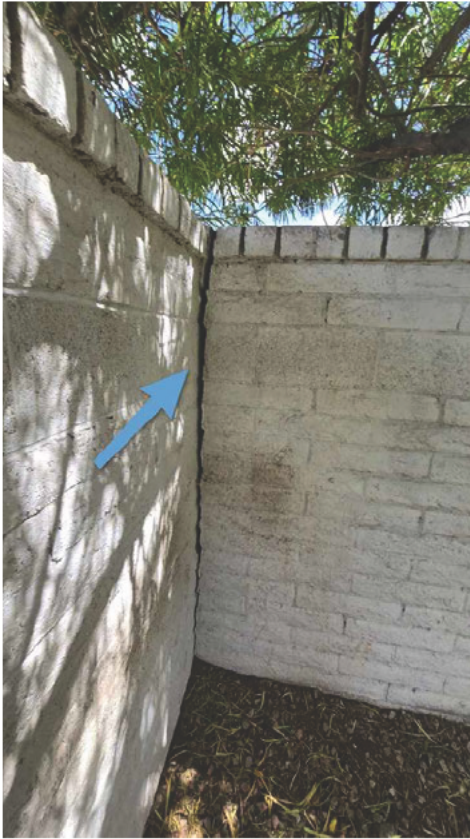
#### 2.11.1 Yard Walls and Gates

The yard walls have some damage/displacement that should be evaluated and repaired by a qualified masonry contractor. There are also some top caps that are loose that should be secured.

Contact a qualified masonry professional.

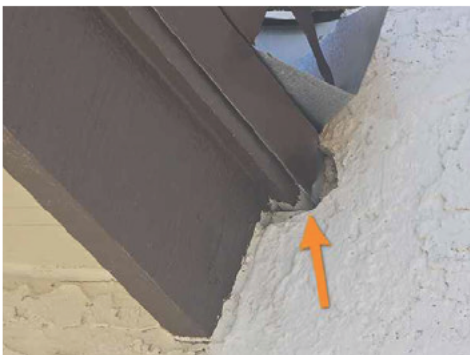
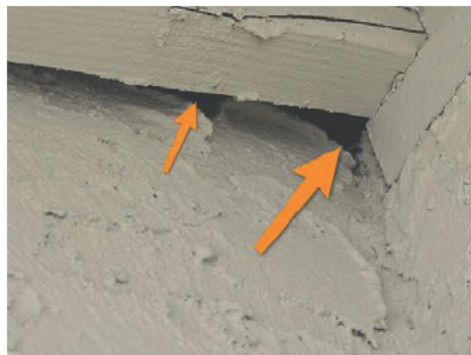
#### 2.12.1 House Wall Finish

Check and seal penetrations, cracks, gaps and dings at the exterior walls including the transition areas at the window/ door surrounds as needed to prevent moisture and or pest intrusion.

Contact a stucco repair contractor

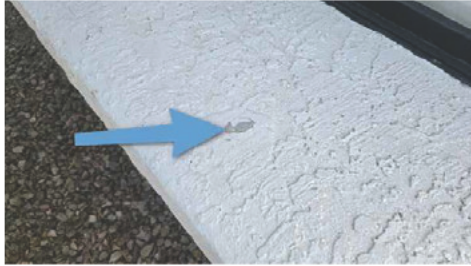
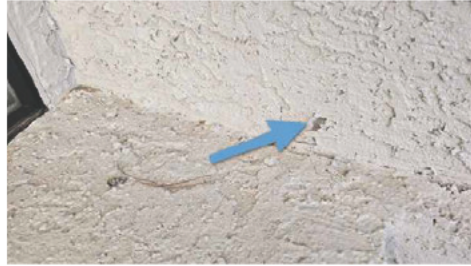
### 2.12.2 House Wall Finish

#### PEELING PAINT

Minor Defect/Maintenance Item

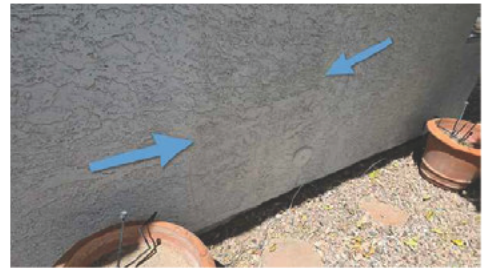
### 2.12.3 House Wall Finish

#### EVIDENCE OF PRIOR STUCCO REPAIR

Minor Defect/Maintenance Item

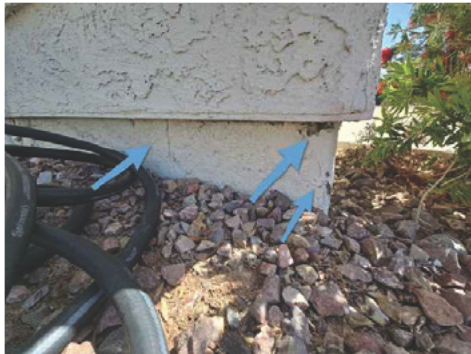
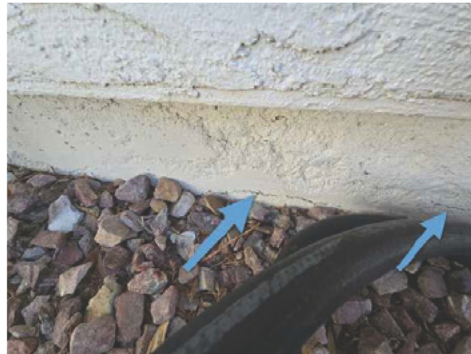
### 3.7.1 Slab Foundation

Noted: Typical concrete degradation, peeling paint, cracks that should be sealed to forestall moisture intrusion.

Contact a foundation contractor.

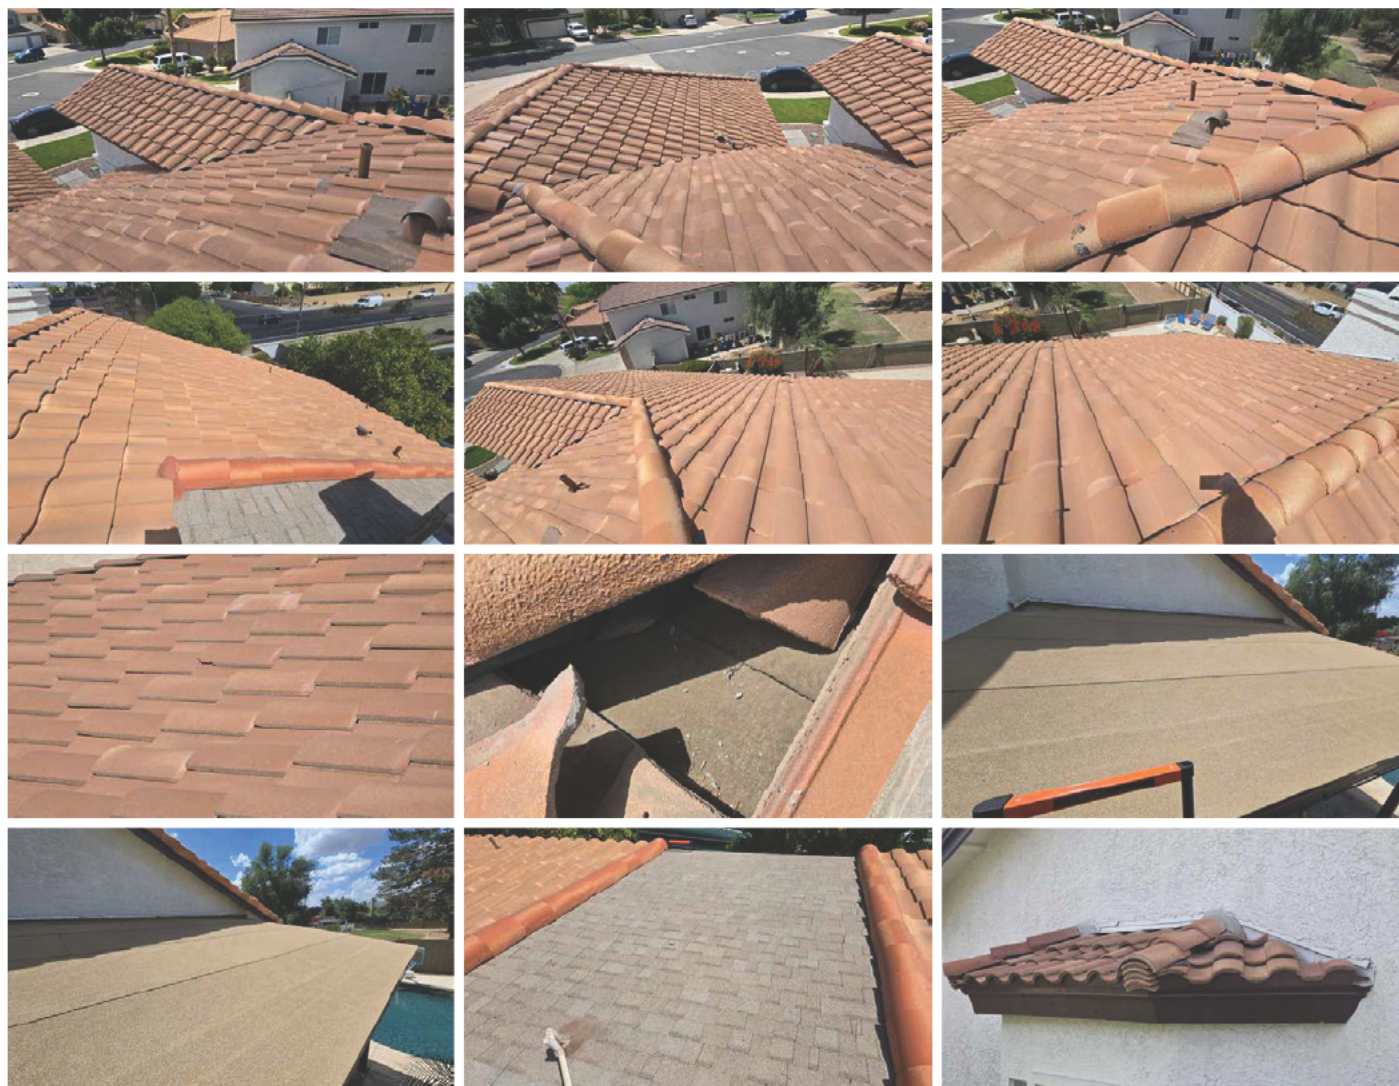
## Roofing Material: Method of Evaluation

### Walked Surface

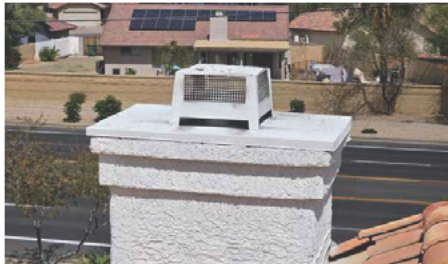
## Fireplace Chimney: Chimney Present

A chimney is present and appears satisfactory and functional at the time of the inspection unless noted otherwise elsewhere.

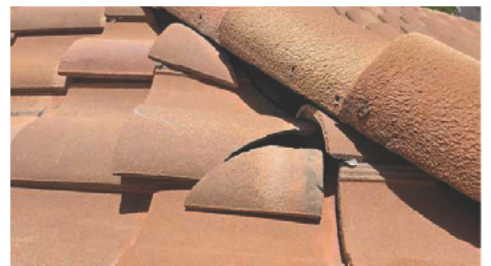
Marginal Defect

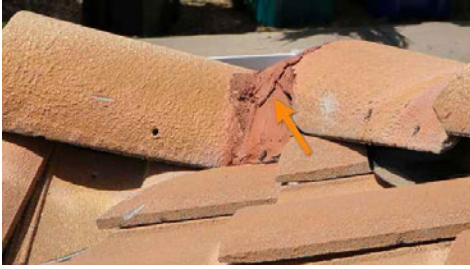
4.1.2 Roofing Material

### CRACKED MORTAR CAPS

Marginal Defect

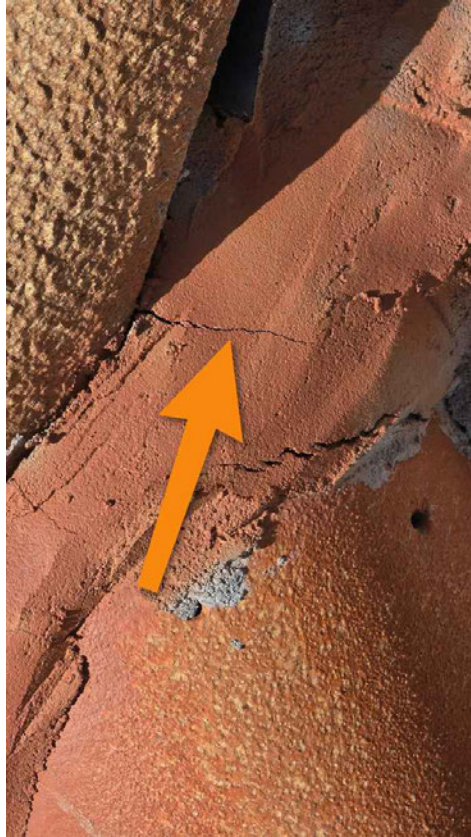
Cracking noted at one or more of the roof's mortar caps. This can cause premature deterioration of the roof material which can cause leaks in the future. It is recommended to have a qualified roofing contractor repair mortar caps as necessary to prevent deterioration in moisture intrusion.

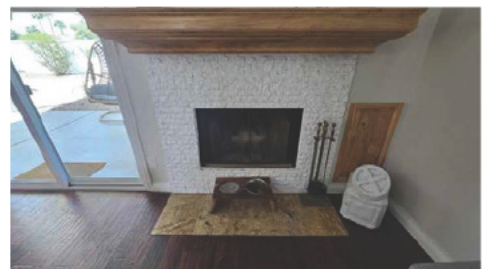
#### 5.1.2 General

##### **HEARTH NEEDED**

Marginal Defect

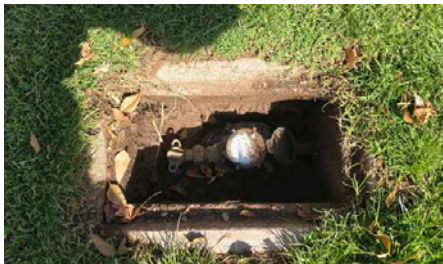
Front

The main water shutoff is located with the water meter.

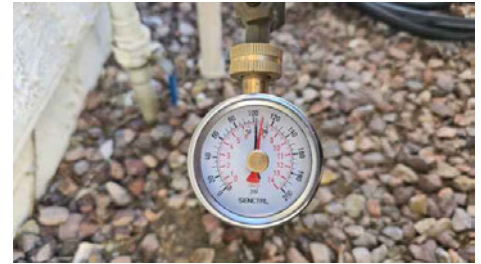
#### Potable Water Supply Pipes: Water Pressure at Distribution Piping

100 PSI

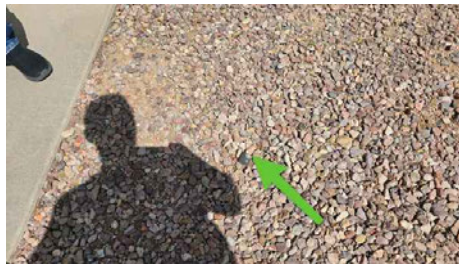
#### Waste & Drainage Systems: Cleanout(s) Location

Front, Only One Located

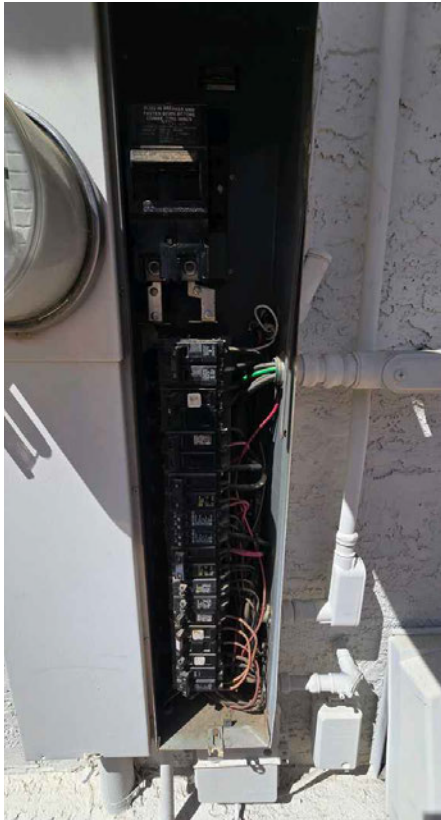
Factory Entrance Conductors, Copper & Aluminum Dedicated Circuits, Copper Branch Circuits

### Service Entrance: Below ground

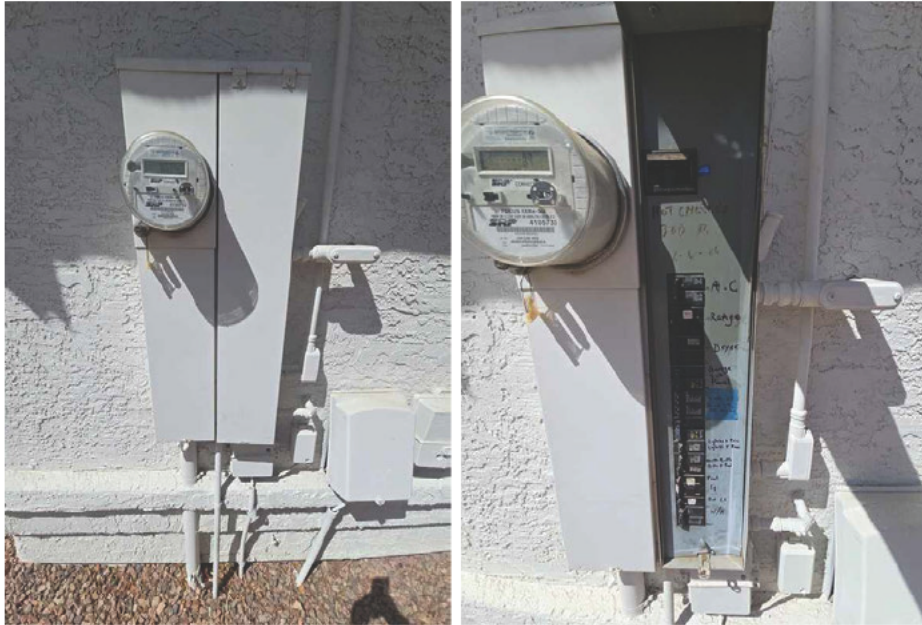
## Electrical General:Main Panel Location

Main Location: East side of building

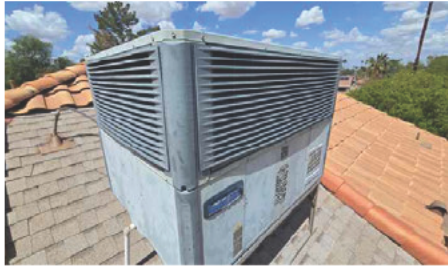
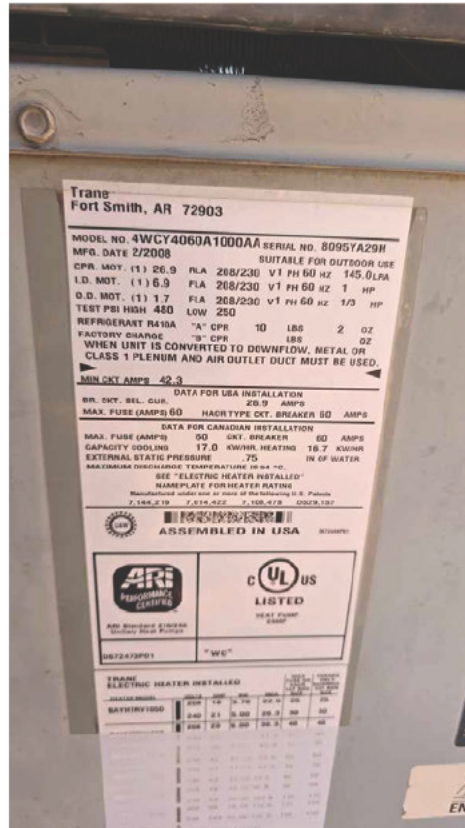
## Cooling Equipment: Air Conditioner Location

### Roof

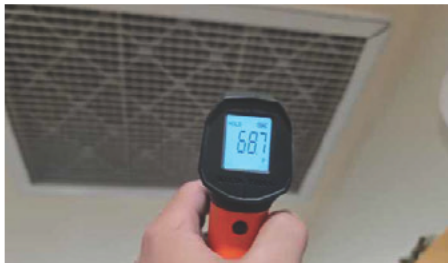
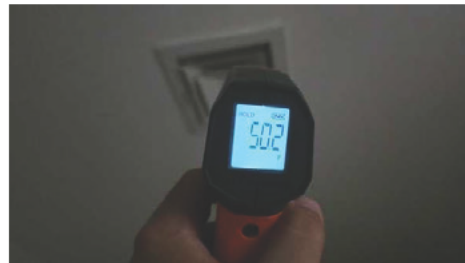
## Cooling Equipment: Acceptable Temperature Splits

The temperature differential splits should be between 18 to 22 degrees. The splits observed fit that range.

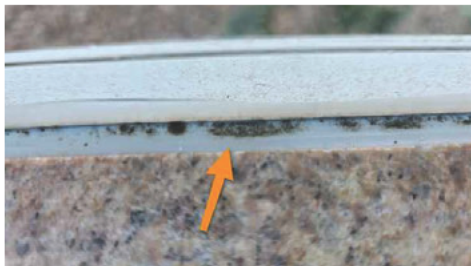
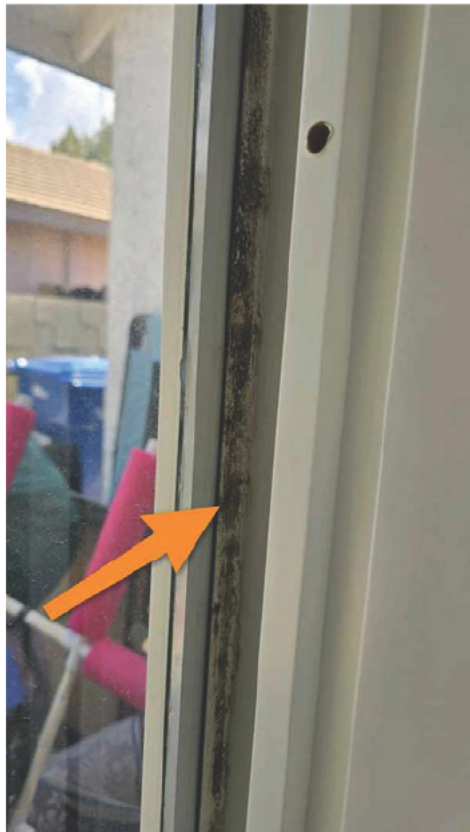
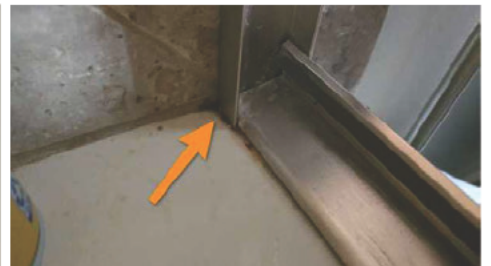
There are multiple spots in the home that have what appears to be surface mold, such as the southeast bedroom window, the primary bathroom windows, and the shower enclosure in the hall bathroom. Recommend a professional cleaning service to remove/disinfect this potential surface mold.

Contact a qualified cleaning service.

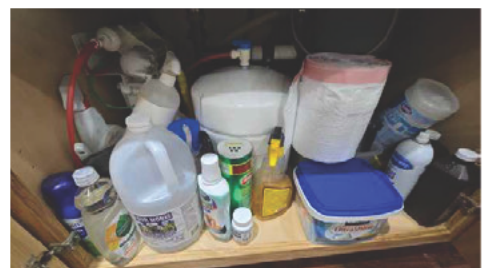
The sink was tested for functional flow and drainage, but there are a significant amount of items stored below the sink which could conceal leaks, if there are any. Recommend further evaluation below the sink after removal of those personal items.

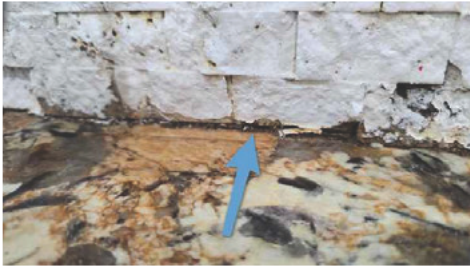
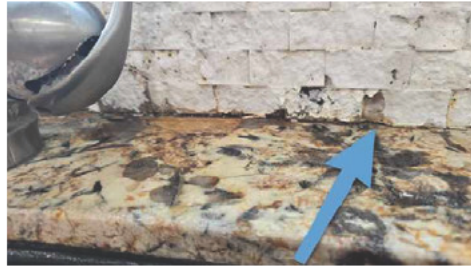
10.6.1 Counter Condition

Gaps noted from backsplash to countertop. The backsplash has some moisture damage. Suggest properly sealing area to prevent future moisture damage behind the backsplash.

Contact a qualified handyman.

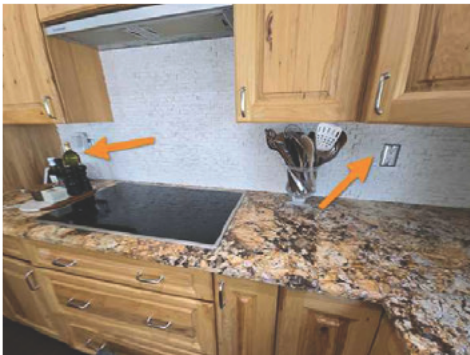
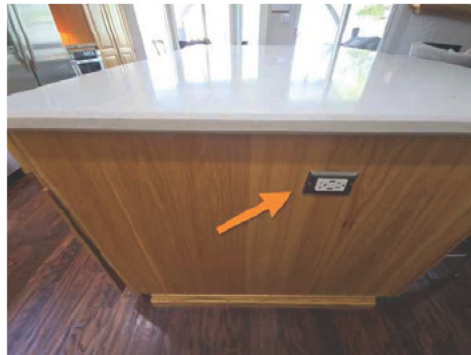
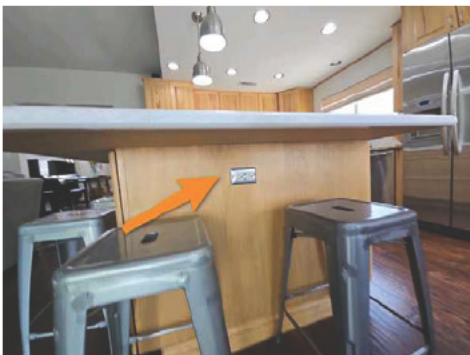
#### 10.7.1 Electrical

##### **NOT ALL GFCI**

Not all of the kitchen outlets are GFCI protected. Recommend upgrading the ones that are not GFCI protected to have GFCI protection.

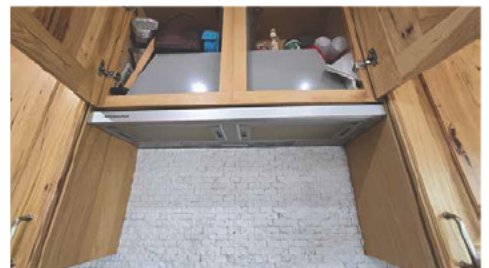
#### 10.9.1 Exhaust Fan

##### **EXHAUST FAN INOPERABLE**

Exhaust fan does not appear to be operable when tested at the time of the inspection. Recommend repairs or replacement. The lights on the unit were also not responding.

Contact a qualified appliance repair professional.

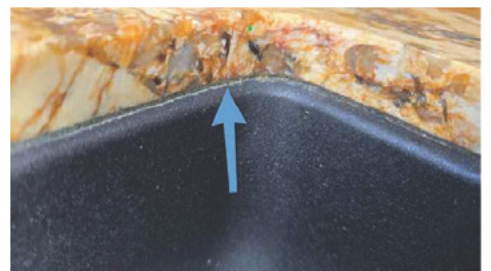
Recommend to recaulk sink where it meets the countertop.

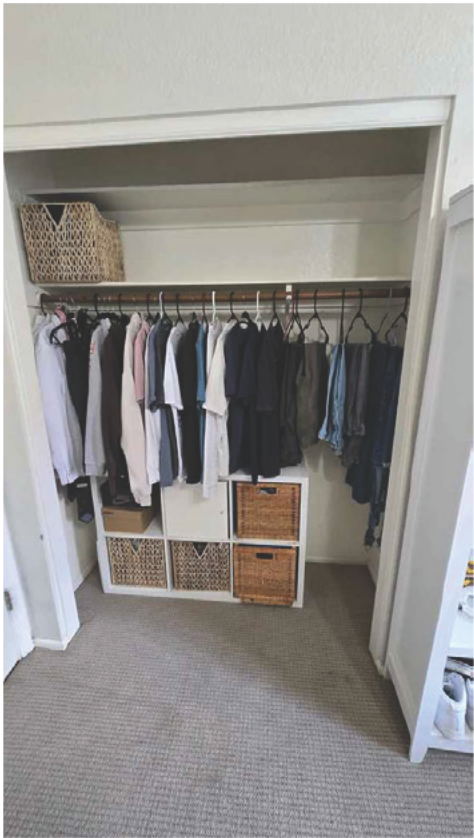
12.2.3 Doors  
**NO CLOSET DOORS**  
SOUTHEAST BEDROOM

No closet doors. Recommend adding doors to closet.

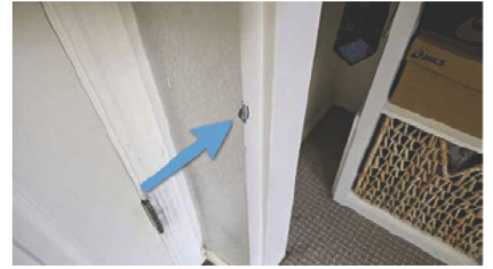
12.5.1 Walls  
**DRYWALL DAMAGE**  
SOUTHEAST BEDROOM

Observed drywall damage in the bedroom. Recommend repair.

Contact a qualified drywall contractor.

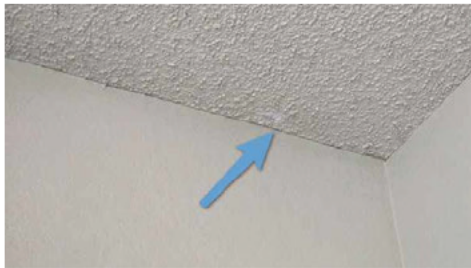
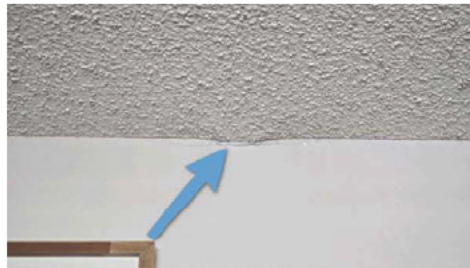
#### 12.6.1 Ceilings

### PAST DAMAGE

There are past areas of damage at the ceiling. Recommend asking the seller for more information or investigating further.

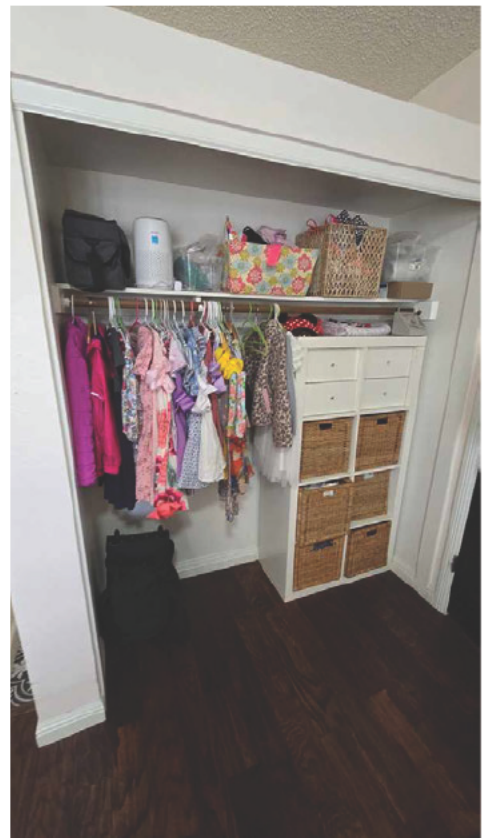
### 14.2.2 Doors

#### **NO CLOSET DOORS**

No closet doors. Recommend adding closet doors.

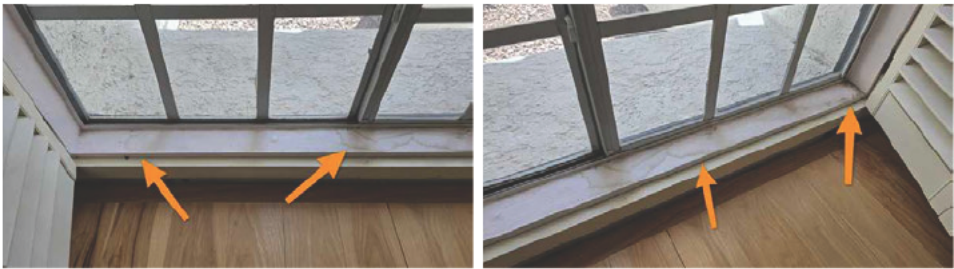
14.3.1 Windows

**WINDOW ALLOWING MOISTURE IN**  
WEST BEDROOM

The bedroom window is allowing moisture in as evidenced by moisture stains. Recommend evaluation and repairs or replacement by a qualified window contractor.

Recommendation  
Contact a qualified window repair/installation contractor.

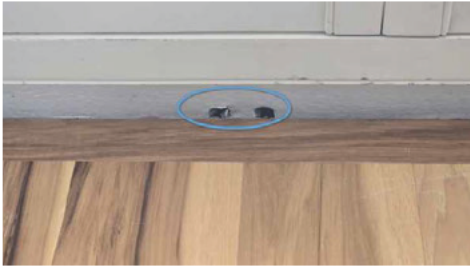
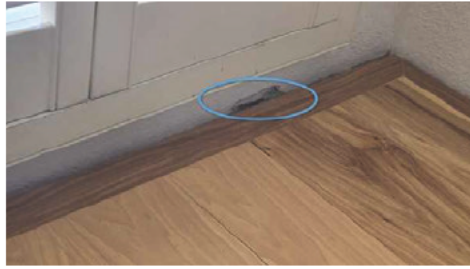
**DRYWALL DAMAGE**  
WEST BEDROOM BY WINDOW

There is damage to the drywall in the bedroom that should be repaired by a qualified drywall contractor.

Recommendation  
Contact a qualified drywall contractor.

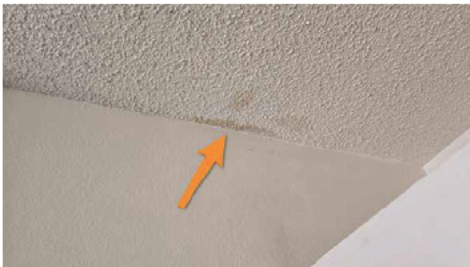
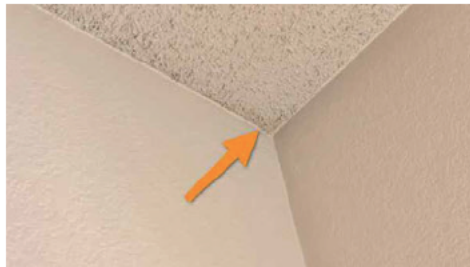
#### 14.6.1 Ceilings

### **PRIOR MOISTURE STAINS**

There are what appears to be prior moisture stains at the ceiling in the bedroom. No current moisture was detected and this could be from before the prior roof replacement. Recommend asking the seller or investigating further.

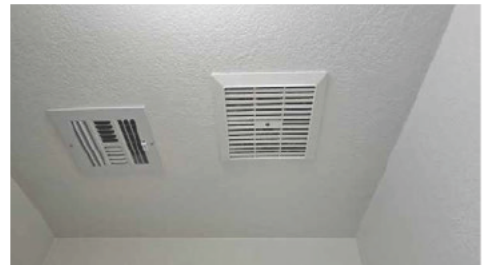
15.1.1 General

The ventilation fan in the bathroom is very noisy, which is indicative of worn components. It will likely need to be replaced soon.

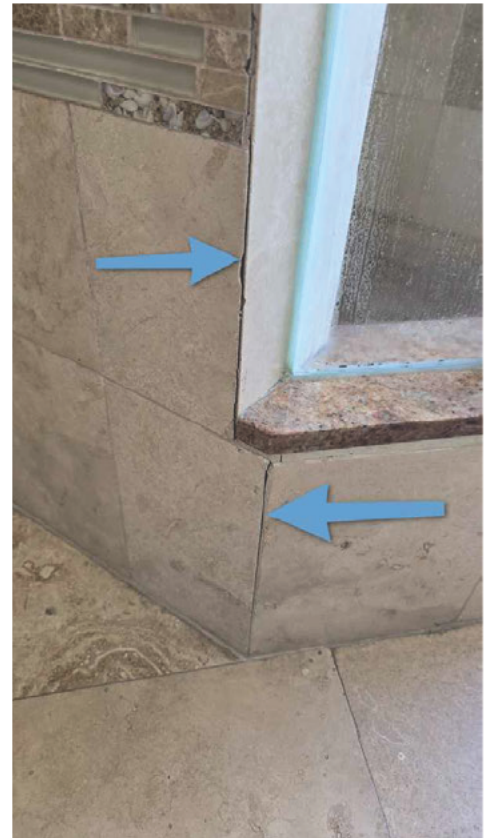
15.3.1 Shower

### GROUT CRACKING/SEPARATION

There is some grout cracking/separation at the shower enclosure that should be corrected.

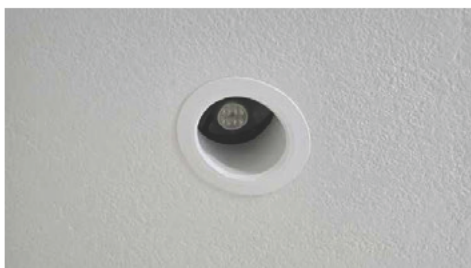
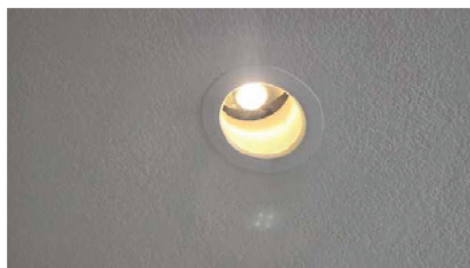
A recessed light in the primary bathroom is not installed well as there is gapping to the attic. The light is also flickering. Recommend repairs or replacement by a qualified electrical contractor.

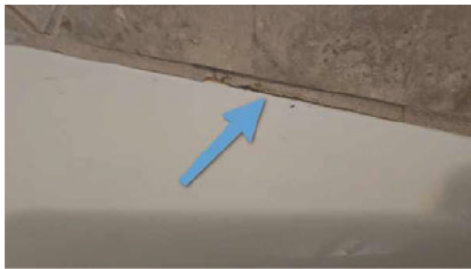
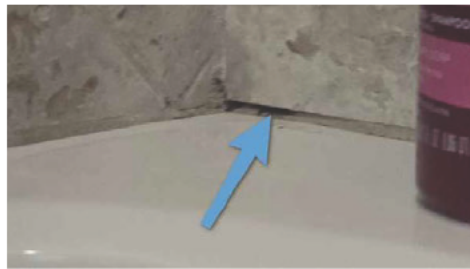
#### 16.9.1 Walls/Ceiling

### DRYWALL REPAIR

There is an unpainted drywall repair in the bathroom that you may wish to ask the seller about. It appears to be related to a toilet paper holder.

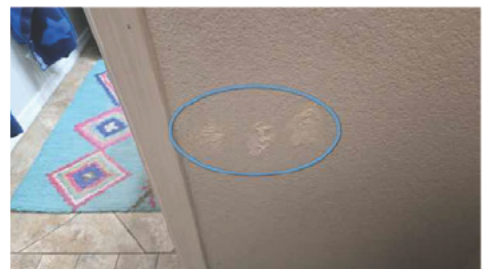
#### 16.9.2 Walls/Ceiling

### MOISTURE DAMAGE/POTENTIAL MOLD

Significant Defect

There is moisture damage to the baseboard and drywall behind the toilet. No current moisture was detected, but it is unknown the extent or duration of the damage behind the wall. Because of this moisture staining, the potential surface mold throughout the home identified in this report, and the evidence of high humidity in this bathroom (rusty air registers), we recommend further evaluation and testing by a qualified mold inspector. We also recommend that the damaged drywall and baseboard be replaced/remediated by a qualified contractor.

Contact a qualified mold inspection professional.

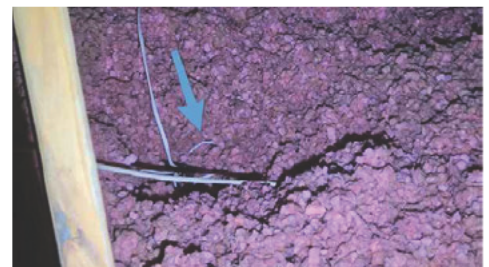
### 19.5.1 Electrical

#### LIGHT NOT RESPONDING

A light in the attic is not responding. This could be because of a burned out bulb, but this could not be verified.

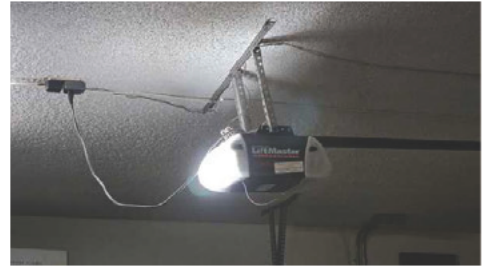
#### 20.5.2 Garage Door Condition

### **WEATHER SEAL DETERIORATING**

The garage door weather strip is deteriorating and should be replaced.

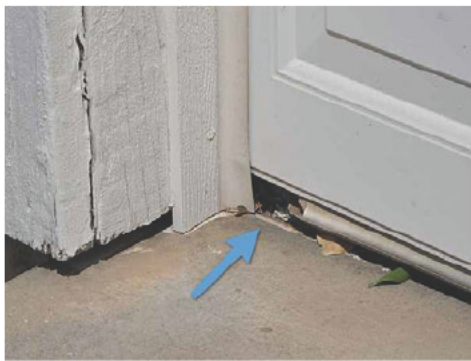
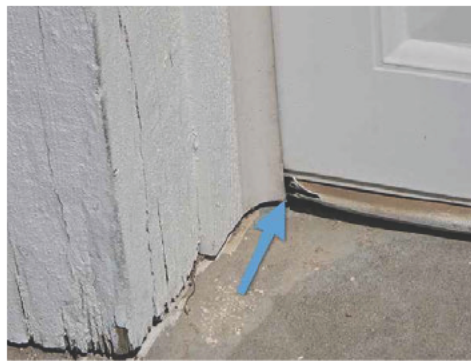
#### 20.6.1 Fire Door

### **INOPERABLE SELF CLOSING HINGES**

Doors from a garage are required to have a 45 minute fire rating and properly seal to keep vehicle gases from entering the home. This door does not have functional self closing hinges. Recommend door technician to adjust hinges to maintain proper safety standards

Contact a qualified door repair/installation contractor.

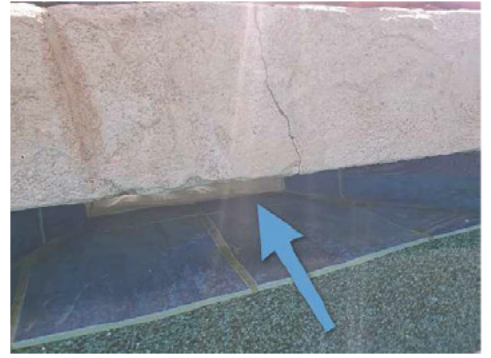
#### 21.5.1 Expansion Joint

### EXPANSION JOINT NEEDS RESEALED

The caulk in the expansion joint has deteriorated and cracked, and should be resealed.

Contact a qualified handyman.

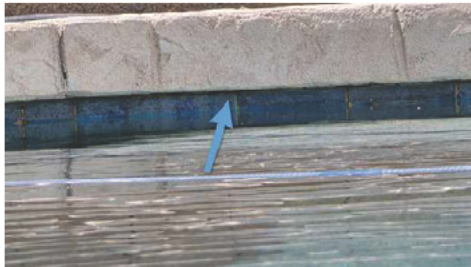
#### 21.6.1 Filter

### PRESSURE GAUGE TOO CLOUDED

The pool filter pressure gauge is too clouded and cannot be read. It should be replaced as it is important to know the pressure the pool filtration system is operating at.

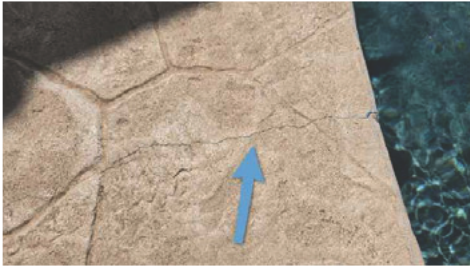
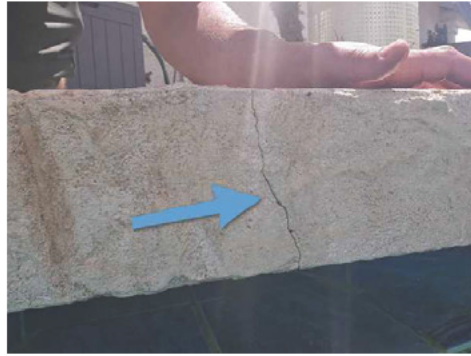
#### 21.8.1 Deck

### TYPICAL CRACKS

The pool deck has some typical cracks. Recommend patching as needed.

Contact a qualified professional.

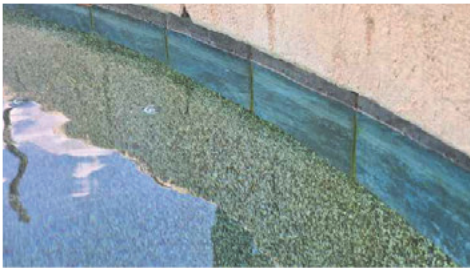
#### 21.9.1 Pool Surface

##### **GREEN ALGAE**

Some green algae was seen on the tiles and surface of the pool. Recommend a pool professional to treat for the algae.

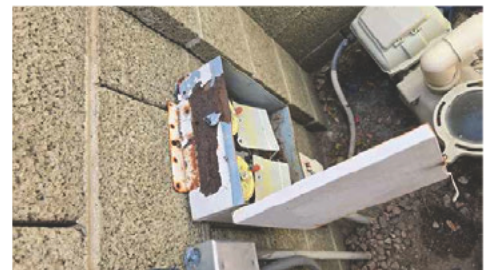
#### 21.12.1 Electrical

##### **POOL TIMER BOX RUSTED**

The pool timer box in the pool equipment area is severely rusted. Recommend replacement of the box.
